# **EVALUATION OF THE STRUCTURAL RESPONSE AND FAILURE OF A FULL-SCALE STITCHED GRAPHITE-EPOXY WING**

Dawn C. Jegley and Harold G. Bush  
NASA Langley Research Center  
Hampton, VA

Presented at the AHS Structures Specialists' Meeting  
October 30-November 1 2001

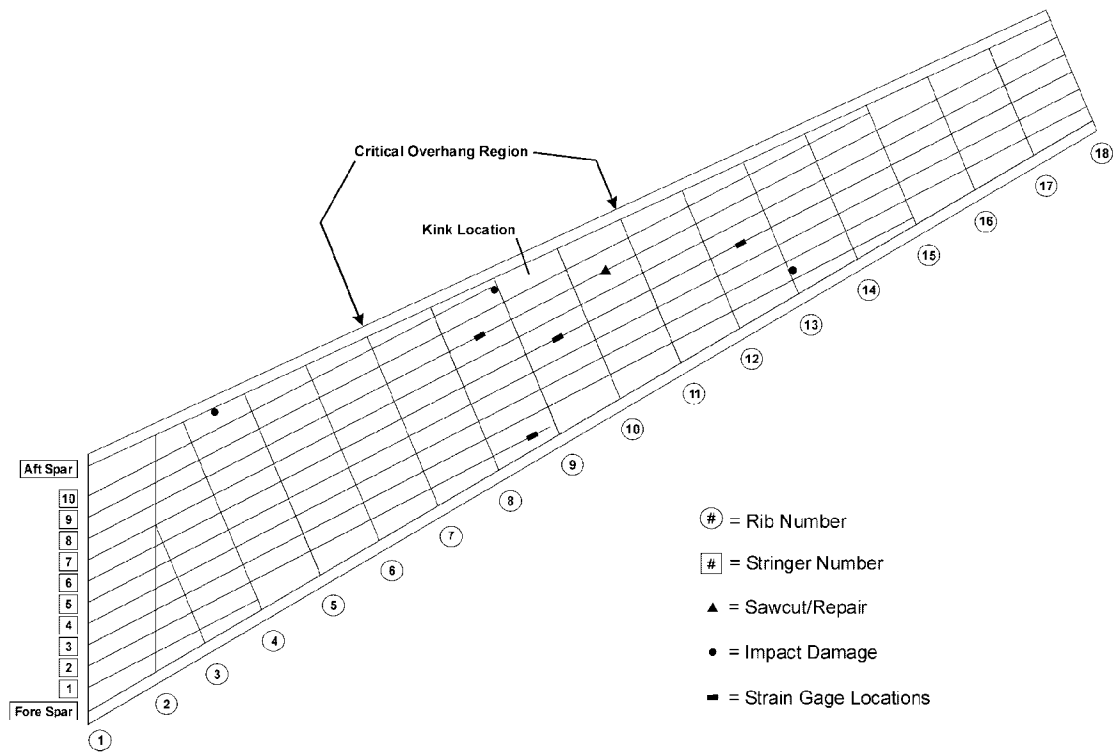
a) Upper cover panel

An overhang of the cover panels with a width of approximately four inches behind the rear spar left an unsupported edge along the length of the test article. This region is shown in figure 2a as the “critical overhang region.” A small initial geometric imperfection in the form of a kink in the upper cover panel was present in the as-manufactured structure. This kink is centered half way between ribs 9 and 10 and has a maximum depth of 0.1 inches. The kink was initially considered minor enough that it would not influence the cover panel structural behavior. However, since the kink is in close proximity to a stringer runout and is in the region of the upper cover panel that

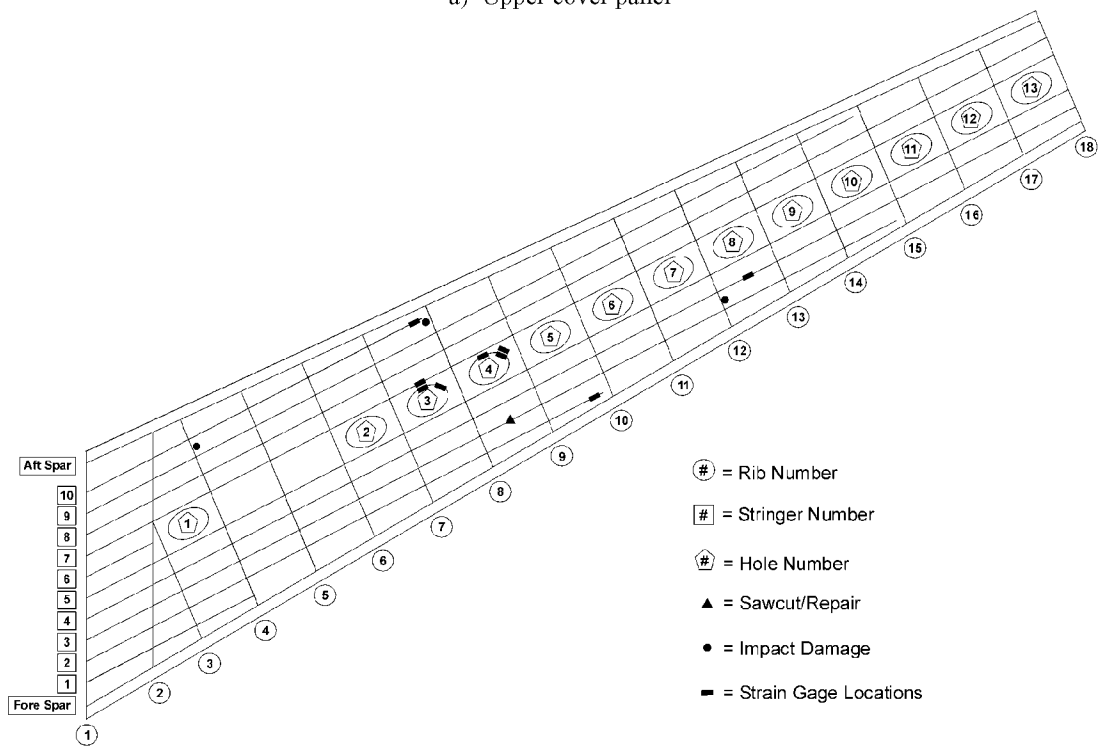
b) Lower cover panel

An air-propelled steel projectile was used to inflict three impacts with an energy level of 83-84 ft-lbs to the lower cover panel. The locations of these damage sites are shown in figure 2b. A steel sphere with a 0.5-inch diameter was accelerated to a speed of approximately 545 ft/sec, resulting in clearly visible damage with dent depths up to 0.135 inches.

Strain gages at the edges of the lower cover panel access holes indicate high strains at these locations. Measured strains at the outboard, rear corner of access holes 3 and 4, between ribs 7 and 8 and ribs 8 and 9, respectively, are presented in figure 18. The strain gage locations are shown in figure 2b. Nonlinearity in the load-strain behavior can be seen at these access holes. The most significant nonlinearity is at the outboard corner of access hole 4. The largest measured strain is at this location and is approximately 0.0096 in./in. at DLL on the surface. Final failure of the cover panel ran through this location. Since analytical results to date do not adequately capture the failure, comparisons of these strains for the access hole edges are not done with experimental results.

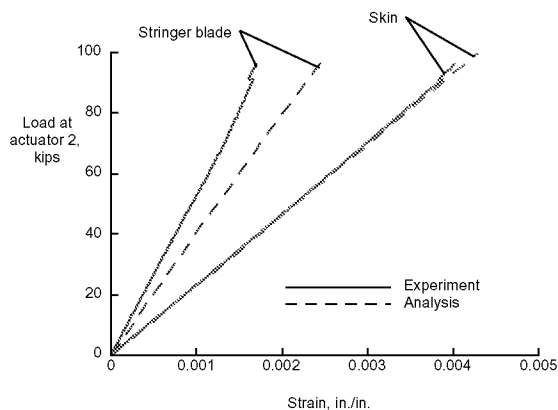
Strains in the lower cover panel at stringer 4 between ribs 12 and 13 and at stringer 7 between ribs 7 and 8 are shown in figures 9 and 10, respectively. Excellent correlation between experiment and analysis is seen in the skin between ribs 7 and 8 and in the stringer between ribs 12 and 13 until immediately prior to failure. The repair, which was not modeled in the analysis, is located between ribs 8 and 9 and may have some influence on these blade strains. Strains remain linear until immediately prior to failure. Strains in the lower cover runout of stringer 2 at rib 10 are shown in figure 11. Analytical strains at this runout agree well with experimental data.

Fig. 10. Strain in stringer blade and skin at stringer 7 in the lower cover panel between ribs 7 and 8.

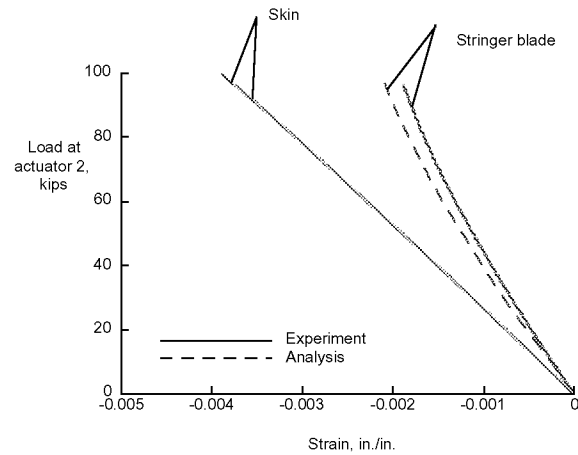
Strains in the upper cover panel at stringer 6 between ribs 12 and 13, at stringer 6 between ribs 9 and 10, at stringer 2 between ribs 8 and 9, and at stringer 8 between ribs 8 and 9 are shown in figures 12, 13, 14, and 15, respectively. For most of these cases, the agreement between analytical and experimental results is good. Excellent correlation between experiment and analysis is seen in the skin inboard from rib 12 and in the stringer outboard from rib 12 until immediately prior to failure. The repair, which was not modeled, is located between ribs 10 and 11 and may have some influence on experimental strain data. Strains do not remain linear in the upper cover panel. The maximum strains in any upper cover runout location are in the runout region at the rear spar at rib 9. Strains at this stringer runout 10.5 inches inboard from rib 9 are shown in figure 14. The blade is tapered in height as well as thickness at this location.

Fig. 14. Strain in stringer blade and skin at stringer 2 in the upper cover panel between ribs 8 and 9.
